Save Oak Savanna

We would like to thank you for your letter in response to the **Notice of Preparation of the Draft Environmental Impact Report for Vesting Tentative Tract No 61553, EAF No, ENV-2005-EIR, Los Angeles County.**

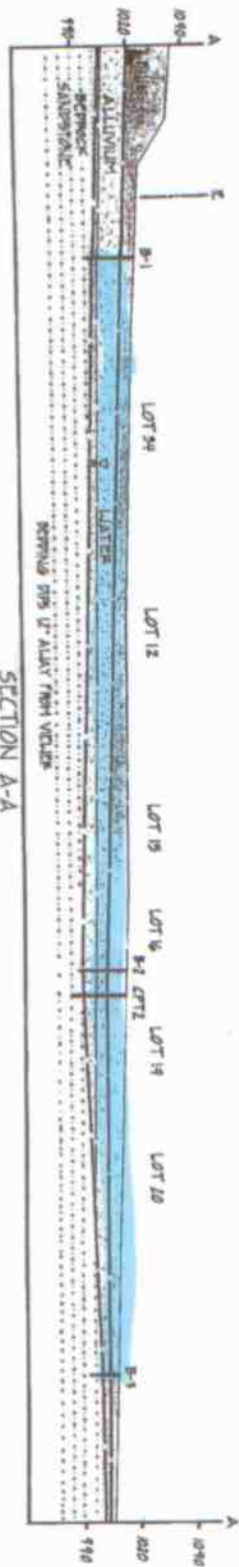
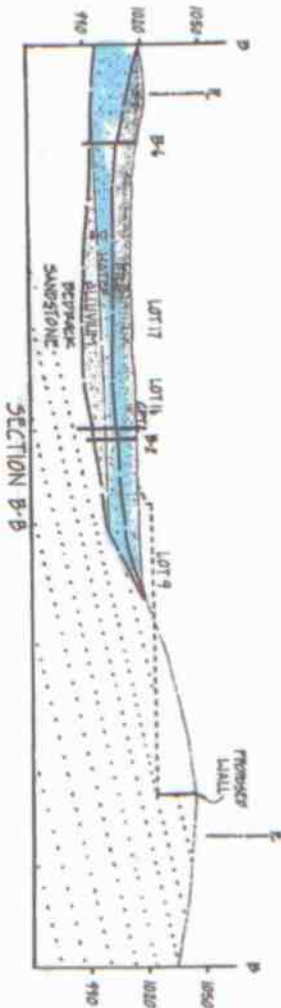
SECTION A-A

The proposed project, surface geologic conditions, and the locations of the test pits, borings, and CPT soundings are shown on Geologic Map #1. Geologic Map #2 is the removal and shoring plan. Subsurface distribution of the earth materials, projected geologic structure, and the proposed project are shown on Sections A and B.

Groundwater was encountered on portions of the site. Generally, groundwater is present within the alluvium in the axis of the main and secondary canyons at 16 to 23 feet below grade and is perched on the bedrock. The water level at the time of the exploration is indicated on the boring logs and is plotted on the geologic cross sections.

Exhibit 1 pg 3 The J. Byers Group encountered groundwater and is indicated on the boring logs and is also plotted on the geologic cross sections.

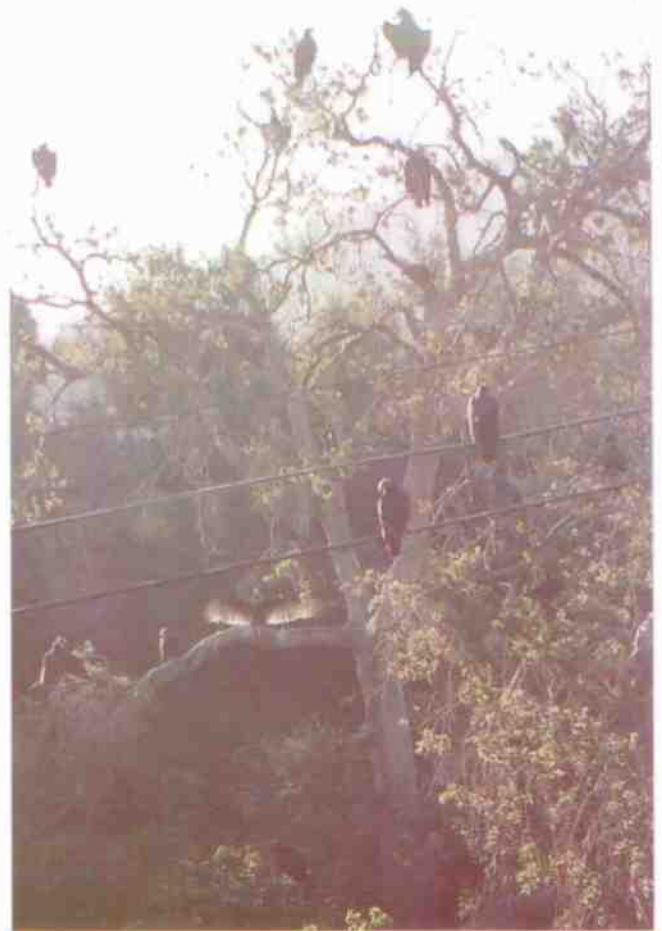
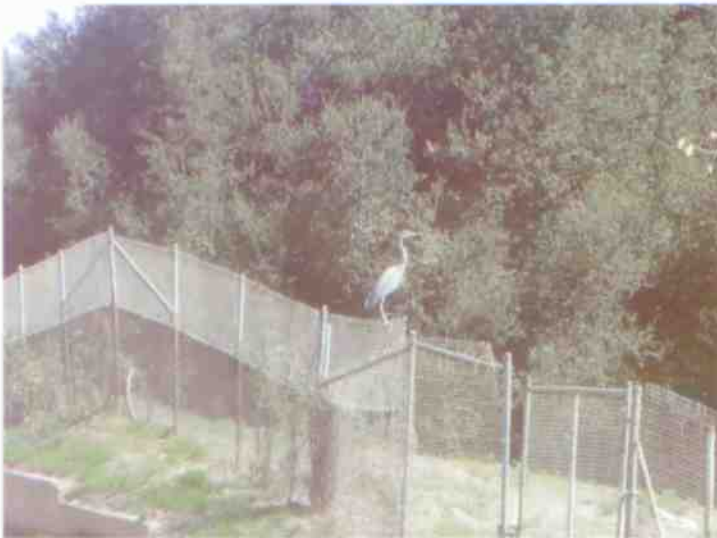
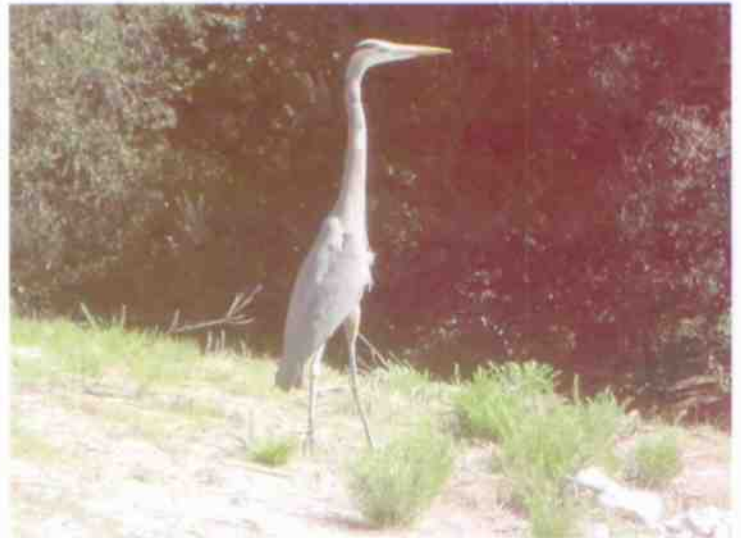
Exhibit 3 pg 3 These are some photos taken of some of the wildlife on the proposed development site. I think at least the blue heron would involve the Migratory Bird Treaty Act.
